ROOM NAME/SPACE

Roof

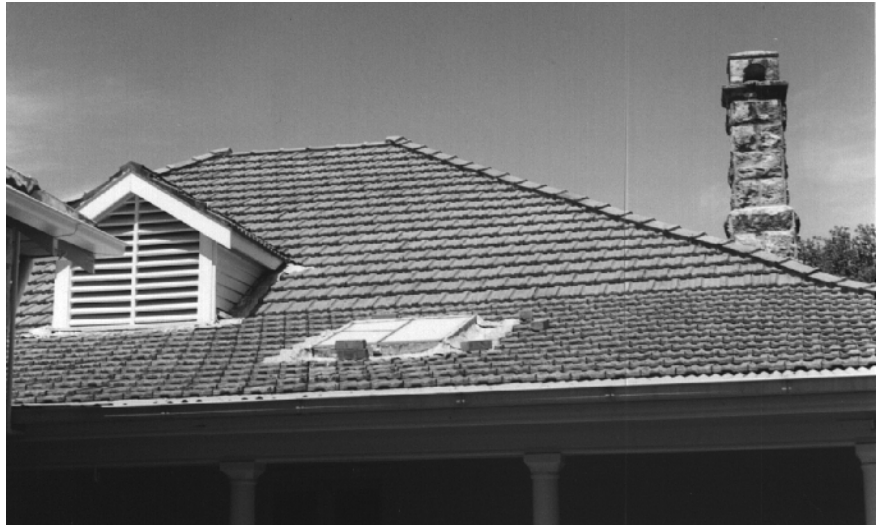
PF photograph 1998

Rear view of the roof, from Courtyard 1 [Room 19]. The skylight lights Room 9. The dormer roof portion may have housed an earlier AC system.

Terra cotta tiled roof generally

Routine conservation maintenance *RCM*
