### ROOM NAME / CURRENT & PREVIOUS NAMES

#### Room 11

Currently used as toilet and store room  
Formerly bathroom corridor

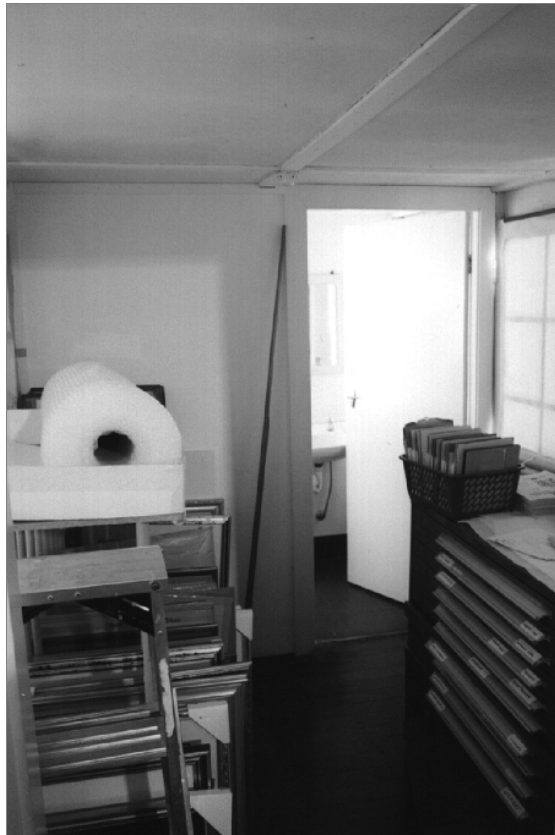
Store section of former bathroom corridor. This area was originally a covered way formed between the main house and the separate bathroom building. It was later enclosed and during NTA ownership a section was annexed to form a toilet. The former bathroom [now AC plant room] is accessed externally.  
**PF photograph 1998**

*RCM* Routine conservation maintenance

*CP* Conservation and interpretation policy to be in alignment with this Conservation Management Plan [refer Volume 4].
